# Advanced Manufacturing Development of a Composite Empennage Component for L-1011 Aircraft

QUARTERLY TECHNICAL REPORT - NO. 13

This report is for the period 1 January 1979 through 31 March 1979

Lockheed Corporation  
Lockheed-California Company  
Post Office Box 551  
Burbank, California 91520

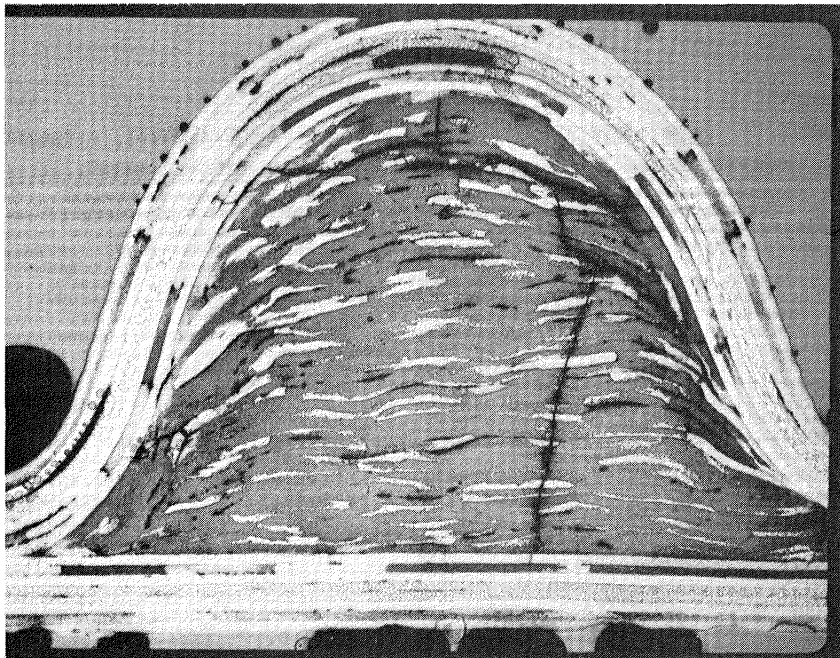
Figure 3-3. Microcracking Through 0 Degree Fibers in "Baseline" Stiffening Bead

Rib development continued through January 1979 to focus on methods of making stiffening beads which were free of microcracks. The bead design upon which development effort had been concentrated is the "baseline" design which is a mass of all  $0^\circ$  fibers embedded centrally in the laminate. Various tooling and fabrication approaches were pursued in the attempt to provide a satisfactory bead. However, the best manufacturing effort, which is shown in Figure 3-3, still revealed cracking through the  $0^\circ$  fibers.

Recognizing that the tendency toward cracking increased with the volume of  $0^\circ$  fibers in the bead, Engineering proposed alternate concepts for bead design. These concepts provided for moving some of the  $0^\circ$  fibers from the bead to the flange, and breaking up the amount of these fibers in any single grouping. See Design Concept "C" in Figure 3-1.

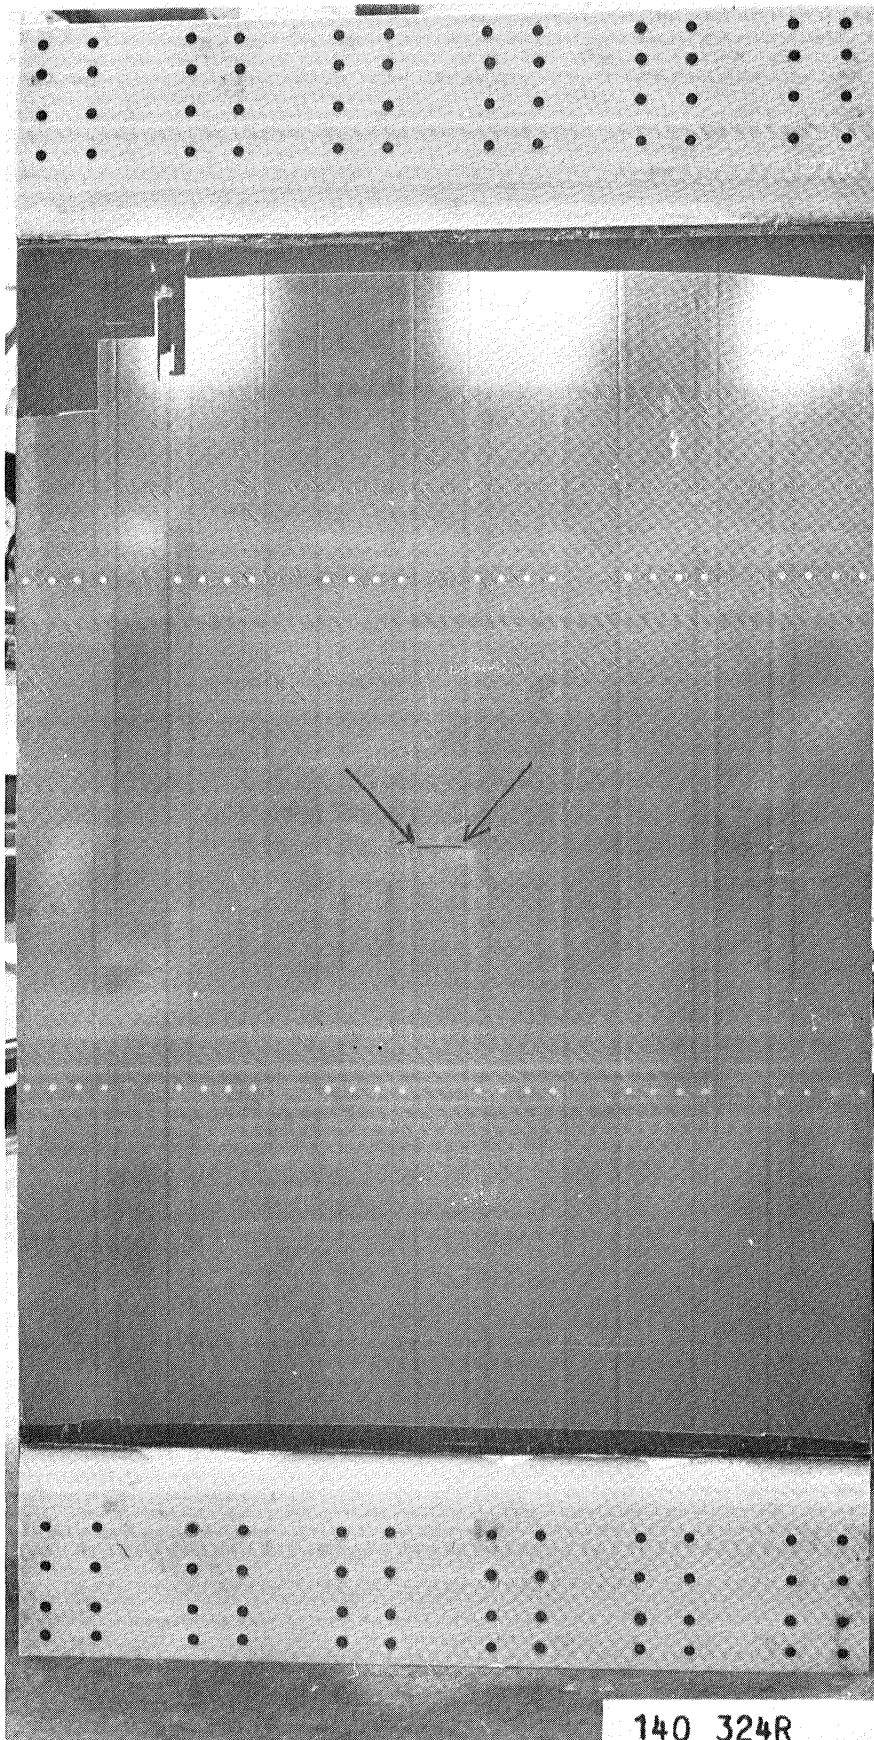
Figure 4-12. Saw Cut Under Center Hat

After the 1/2 lifetime (18,000 flights) the limit load cycles were applied. A loud "pop" was audible and visual examination showed that cracks had developed in two areas: (1) at the end of the saw cut in the skin, 3 cracks 1/8 to 3/16 inches long; and (2) in the hat side wall at the region of the saw cut intersection. The skin cracks were examined ultrasonically and were found to be surface delaminations only. The hat cracks and damage were confined to the side wall of the hat in an area about 3/8 inches in diameter. The flight-by-flight spectrum was again initiated for another 1/4 lifetime. During the first 1800 flights of this sequence, the crack on the hat sidewall grew to the crown of the hat and stopped. No further growth was noted for the duration of this run other than some minor surface layer fiber delaminations. Also noted were some minor amounts of surface fiber lifting at countersunk fasteners between Bays 2 and 3. The spectrum testing was continued for an additional 1/4 lifetime (full lifetime total) with no change in growth noted. Up to this time 2 cycles of limit load had been applied to the specimen.

After completion of the full lifetime (36,000 flights), the saw cut was extended completely through the hat including the crown and both flanges as shown in Figure 4-11c. The spectrum loading was then continued for an additional 1/2 lifetime. Only minor crack growths were noted.

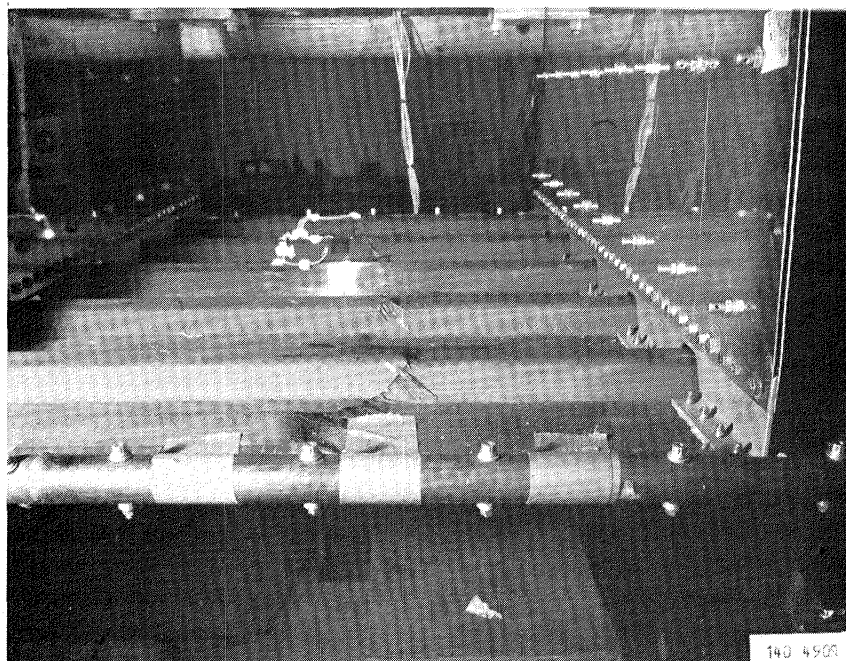
Figure 4-16. Stiffener Side After Failure

After completion of this sequence, the limit load cycles were again applied. Failure of the panel occurred at 96% of limit load in compression. Figures 4-16 and 4-17 show the panel after failure. The panel had carried 100% of limit load in tension and was in the limit load compression cycle at failure.

The test demonstrated that the cover can withstand one-half lifetime of fatigue loading and can carry limit load with obvious partial damage. The panel in fact sustained one-and-a-half lifetimes of fatigue and two applications of limit compression and three applications of limit tension. Failure in the compression mode was due to the high stress concentration at the end of the saw cut which was a tenth-inch wide. Local surface delaminations at these ends precipitated failure.
